Experimental Survey on Maintenance and Safety of Tractor PTO Drive Shafts in Central Italy

**M. Cecchini, D. Monarca, P. Biondi,
G. Menghini, A. Coletta**

Dept. Geology and Mechanical Naturalistic and Hydraulic Engineering for the Territory
Tuscia University, Viterbo, Italy –
ergolab@unitus.it

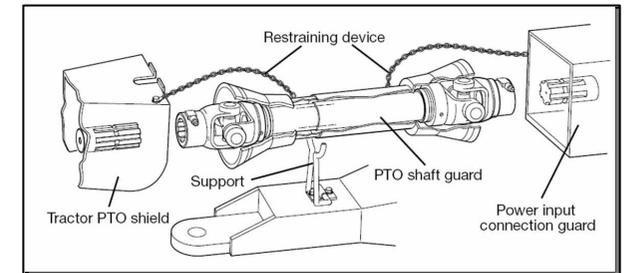
Cone and tube type guard (source: HSE)

The terminal cone guards are sized to cover only the internal drive shaft forks or in the case of wide-angle shafts outside the center of the joint. Appropriate and similar protection (covers, caps, shields) are necessary and they have to be present both on the machine and on the tractor: particularly, as required by EN 1553:2001, these protections should overlap those the propeller shaft for least 50 mm when the gimbal is aligned. A safety guard for drive shafts can not be marketed unless it has been approved according to existing standards (EN 1152).
